FOOD LION #2839 REVISED DRAIN SURVEY PER ENGINEERING REVIEW

11-08-2021 5/17/2021 - 11/16/2021

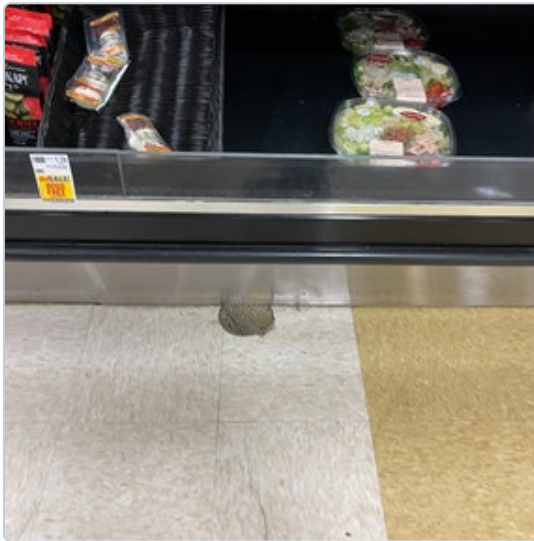
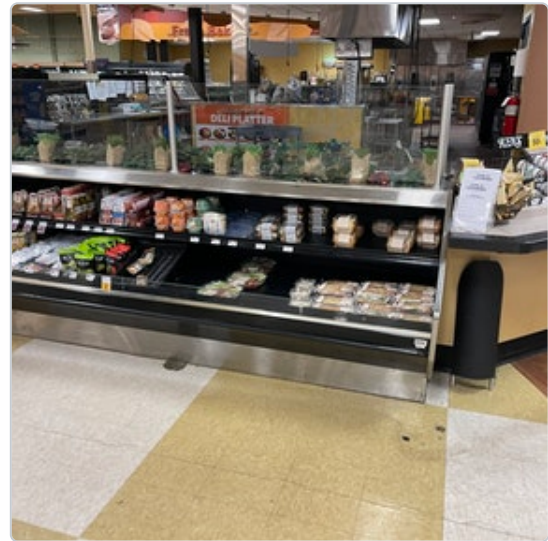
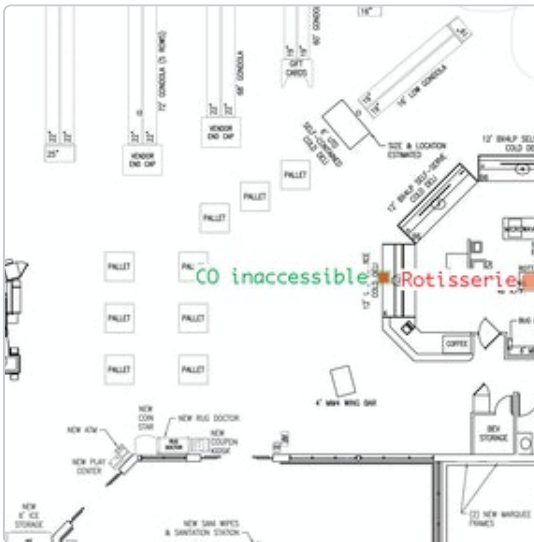
Post 16 - Deli cleanout inaccessible

Cleanout should be made accessible for full inspection.

Per email from Food Lion Engineering on 11/8/21, item is to be included in remodel documents.

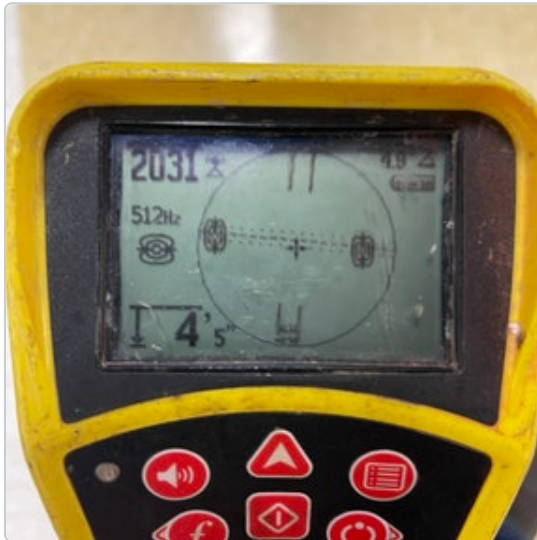
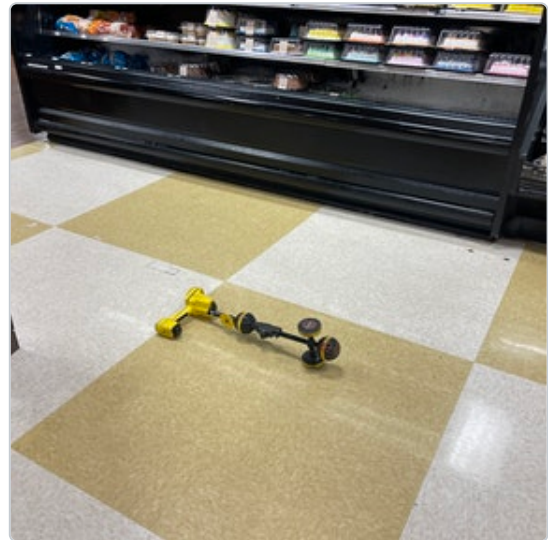
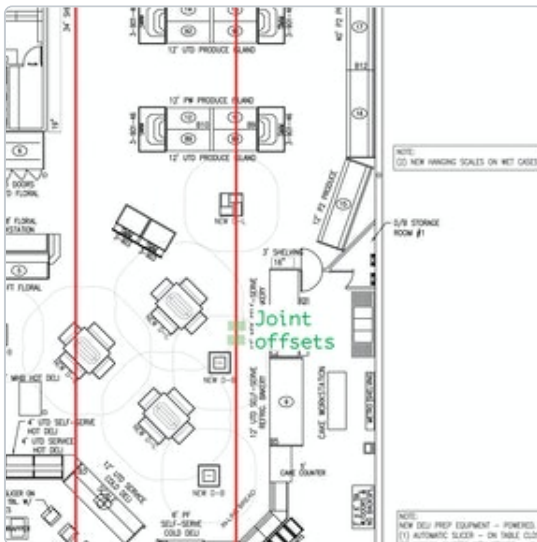
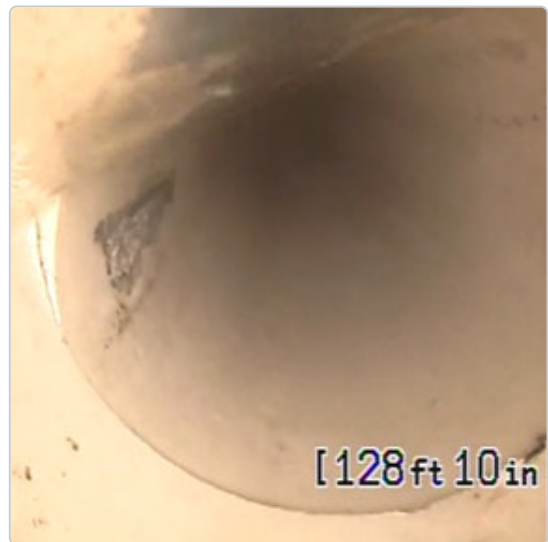
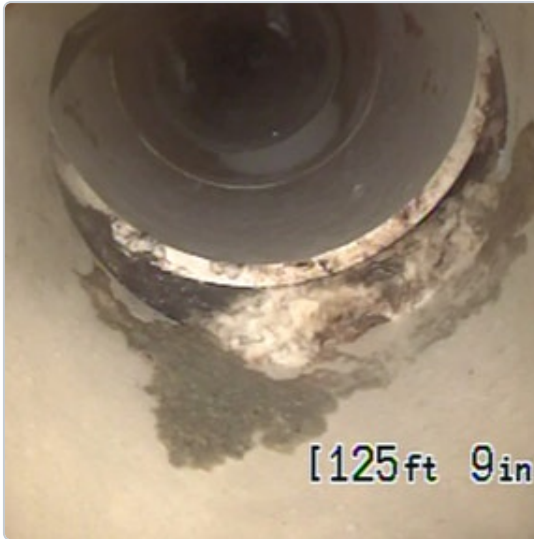
Post 17 - Cleanout CO7 line - Joint offset at 126' and 128'.

Issue is located 49' off deli front wall and 19'3" left of deli right wall; line is approximately 4'7" deep.

Per email from Food Lion Engineering on 11/8/21, item is to be included in remodel documents.

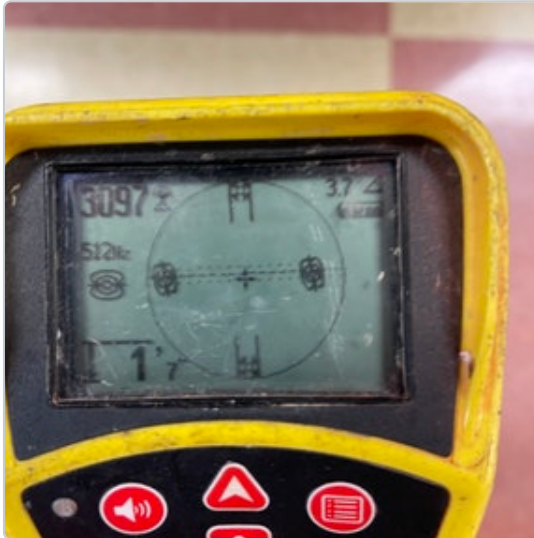
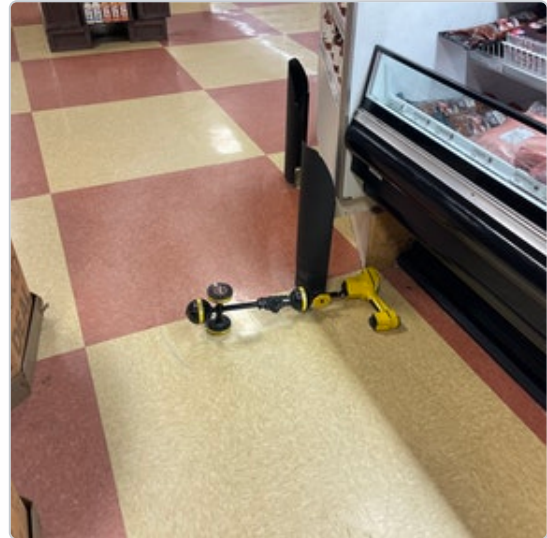
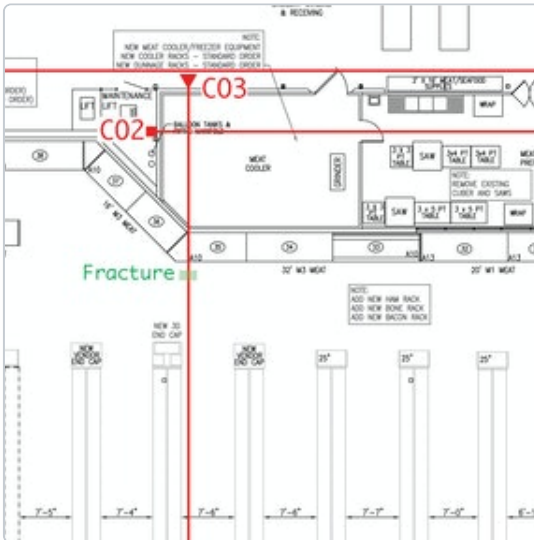
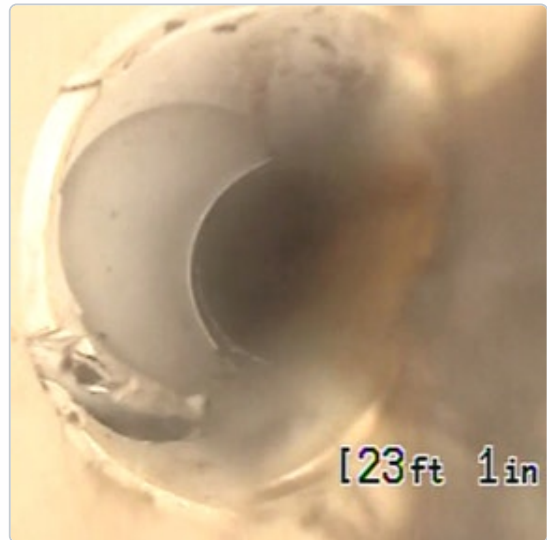
Post 14 - CO3 line - Fracture at 28'.

Repair. Issue is located 108'6" right of right sales wall and 6' off rear sales wall; line is approximately 1'7" deep.

Per email from Food Lion Engineering on 11/8/21, item is to be included in remodel documents.

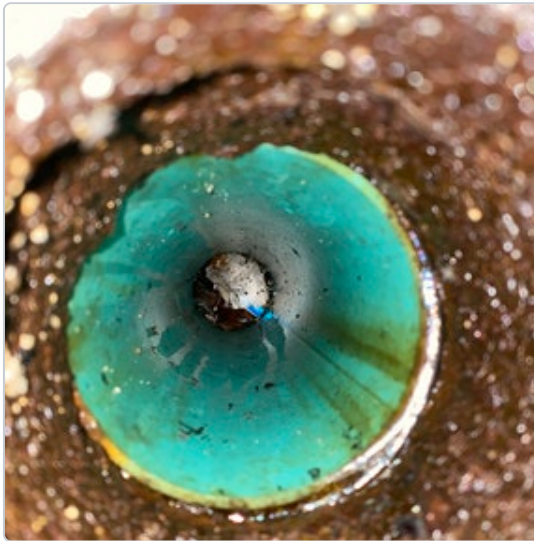
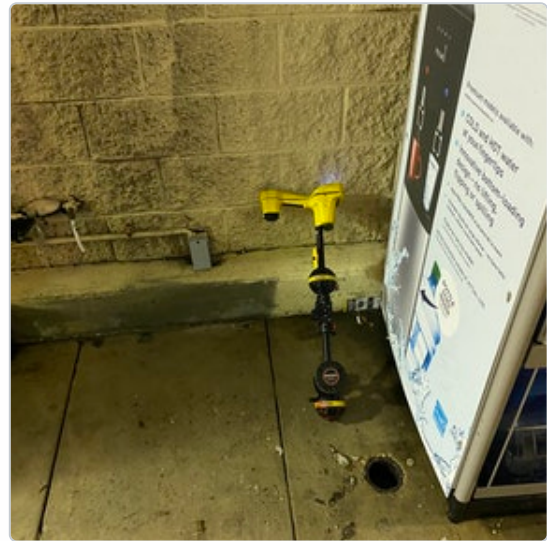
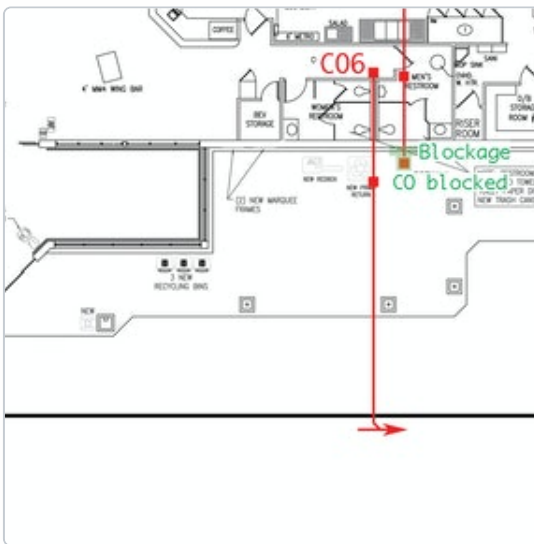
Post 15 - CO5 line blockage

Blockage located on front right sidewalk, in cleanout riser. Remove blockage. Crescent to inspect line after blockage has been removed.

Per email from Food Lion Engineering on 11/8/21, item is to be included in remodel documents.

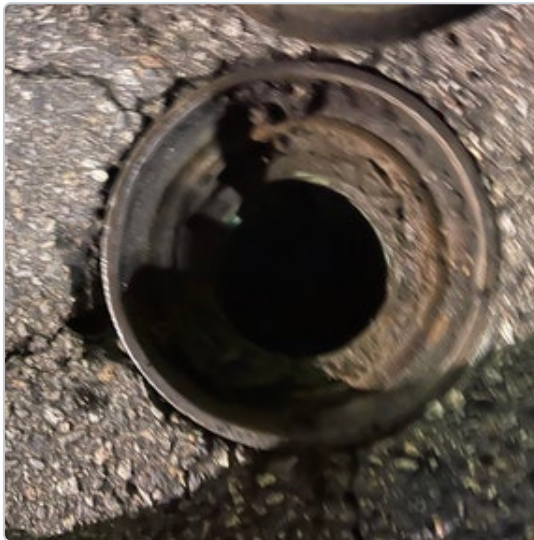
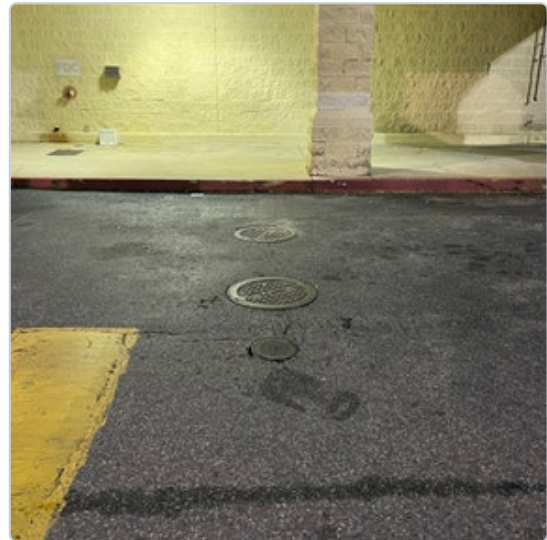
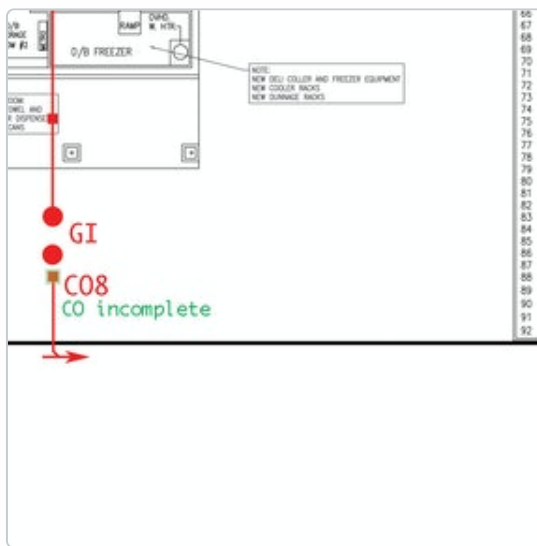
Post 18 - Grease interceptor outlet cleanout; CO8 lacking plug

Lacking plug prior to arrival. 6", install.

Per email from Food Lion Engineering on 11/8/21, item is to be included in remodel documents.

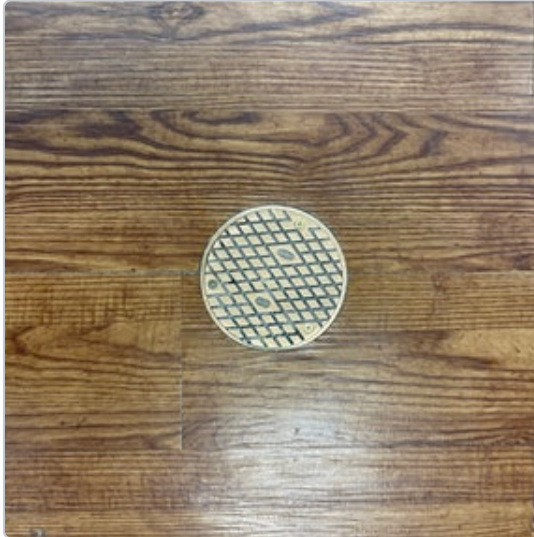
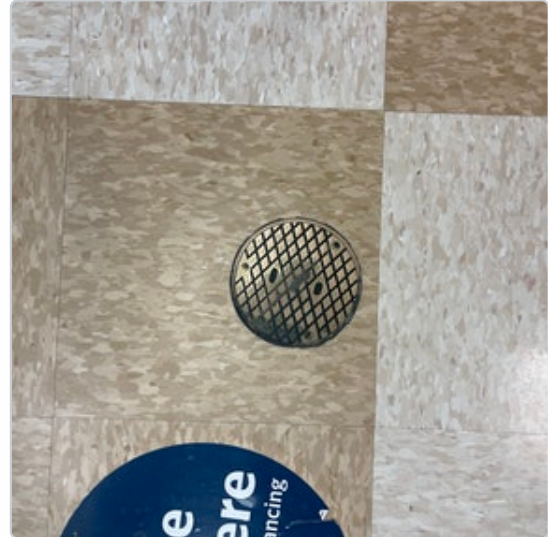
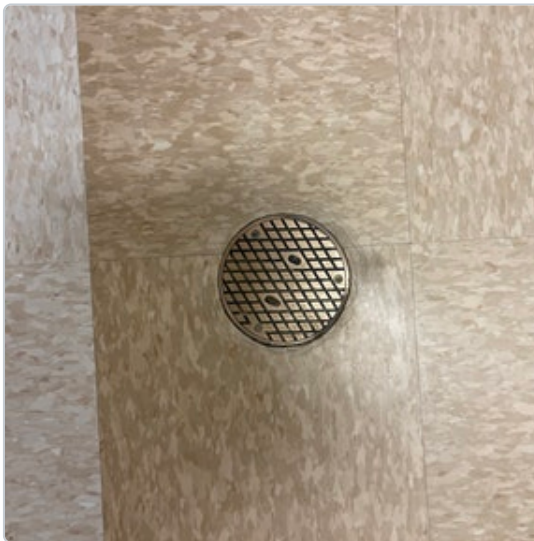
Post 3 - Construction Manager to review cleanouts for possible repair (for reference)

The sales floor cleanouts typically have surrounding tile damage / unlevel / should be cleared of excess wax and debris. Ensure all are level with finish floor upon closeout of remodel. Consider replacing fixtures.

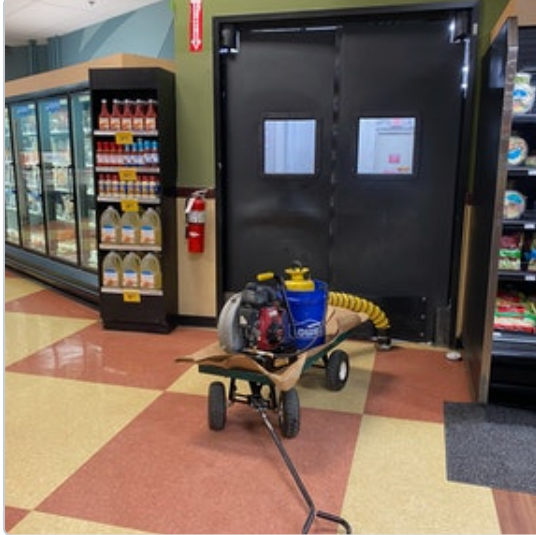
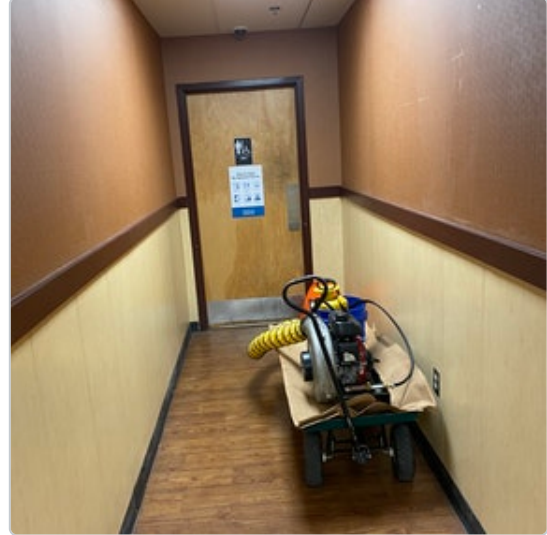
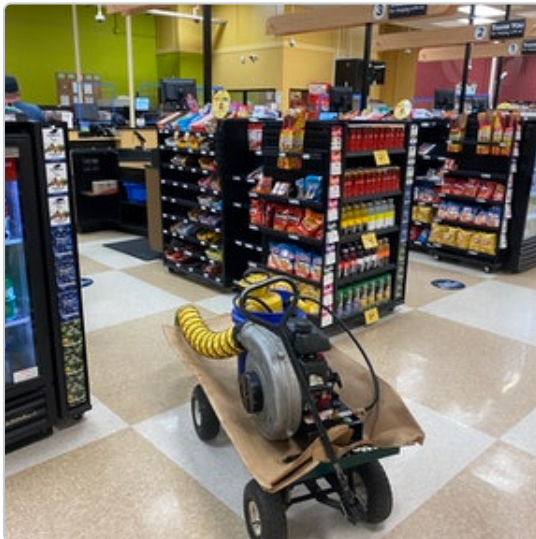
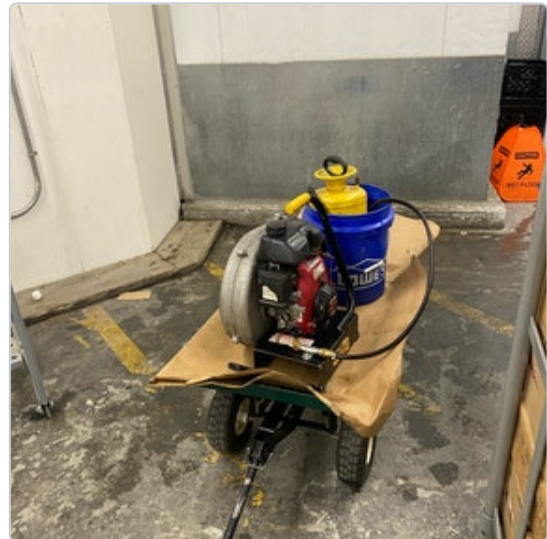
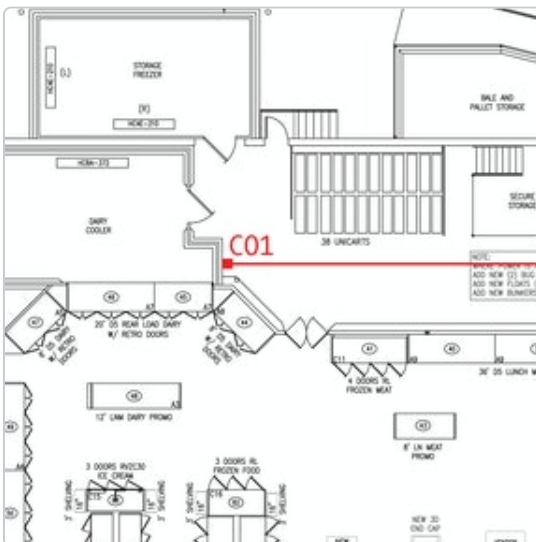
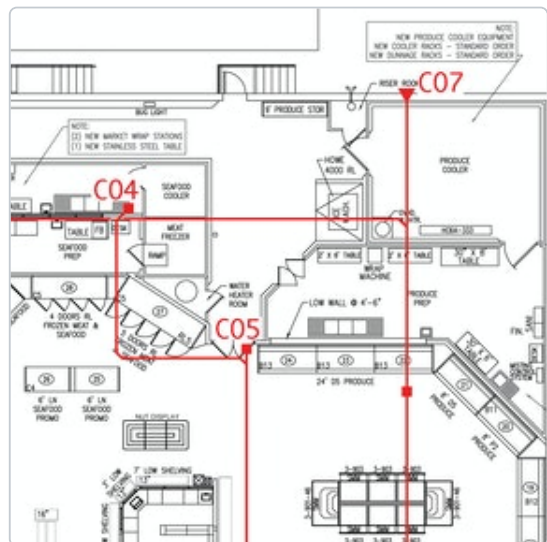
Post 5 - Smoke test performed from cleanouts C01, C05, C06, and C09-09/21/2021

Post 6 - Smoke test showed no issues - 09/21/2021

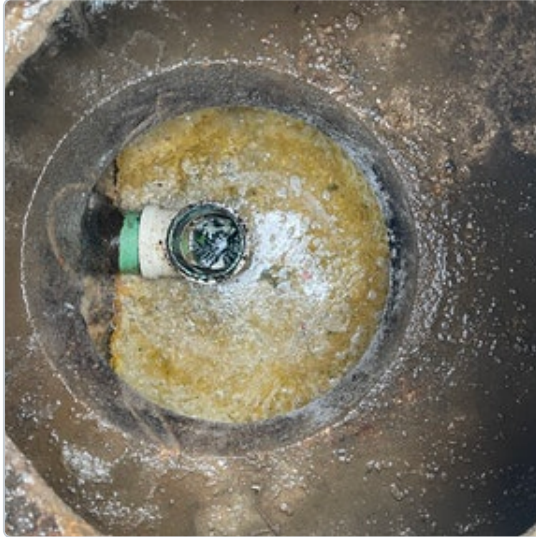
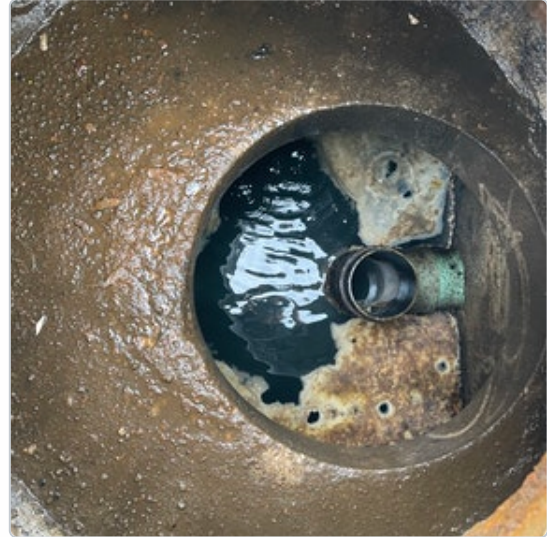
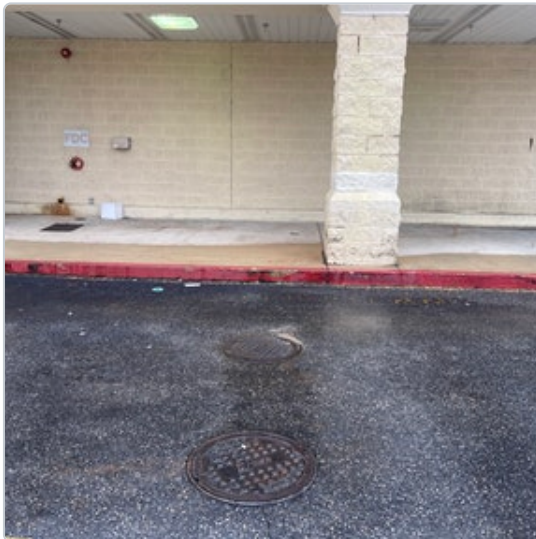
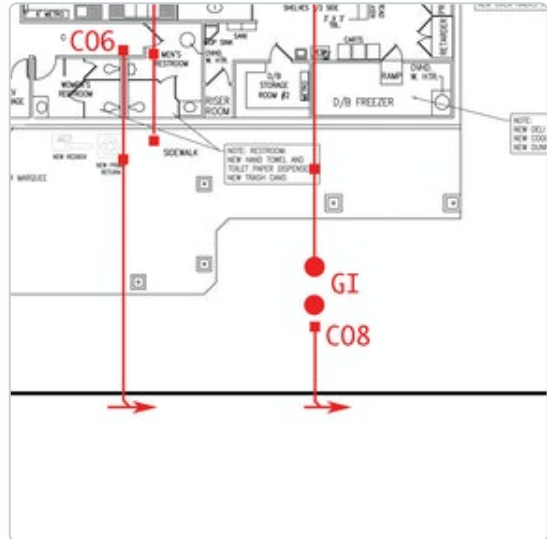
Post 9 - Grease interceptor - Appears to be functioning normally with inlet 1" above outlet.

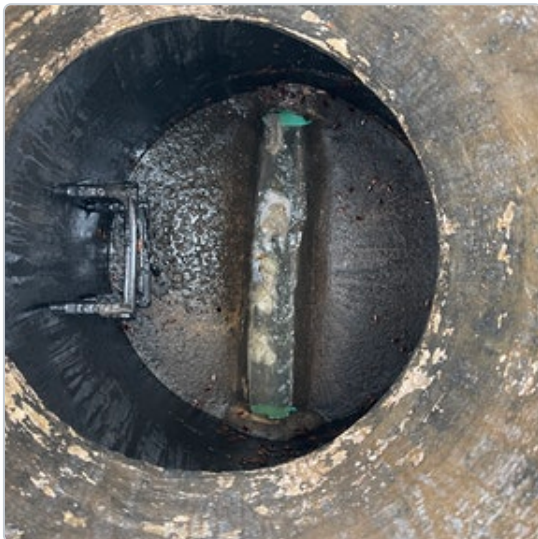
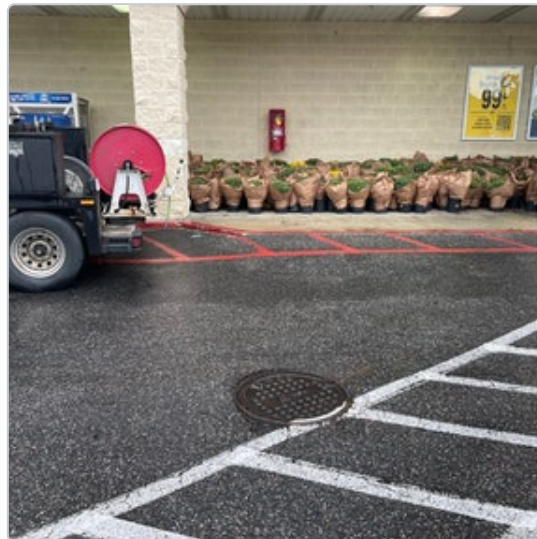
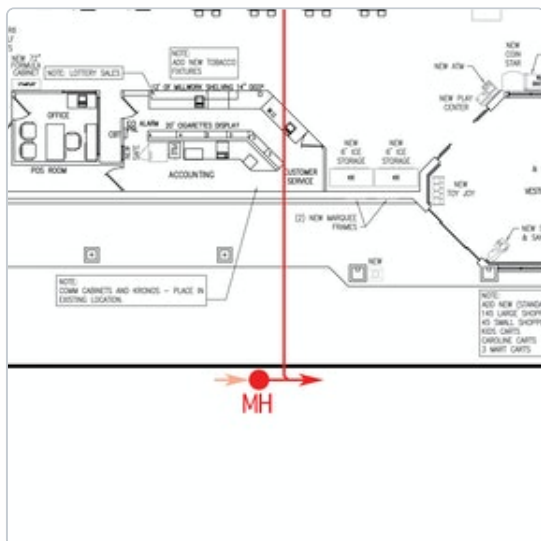
Post 8 - Manhole

Manhole is flowing/operating normally.

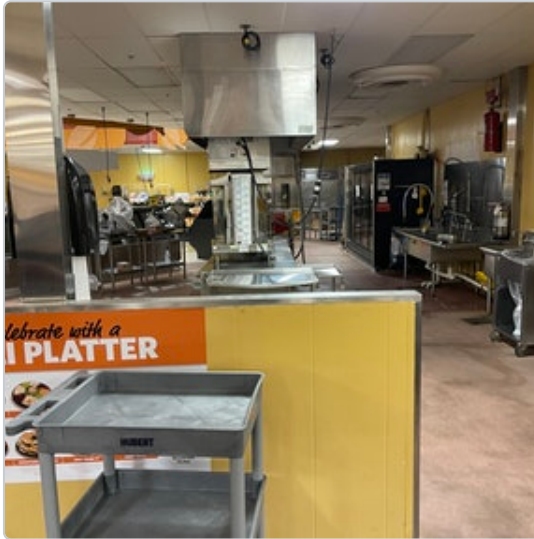
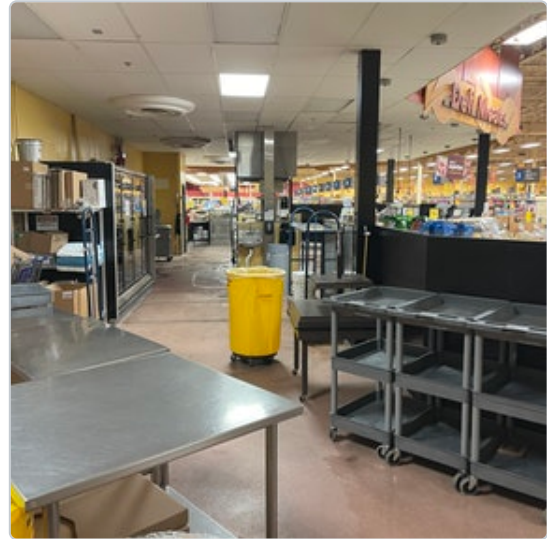
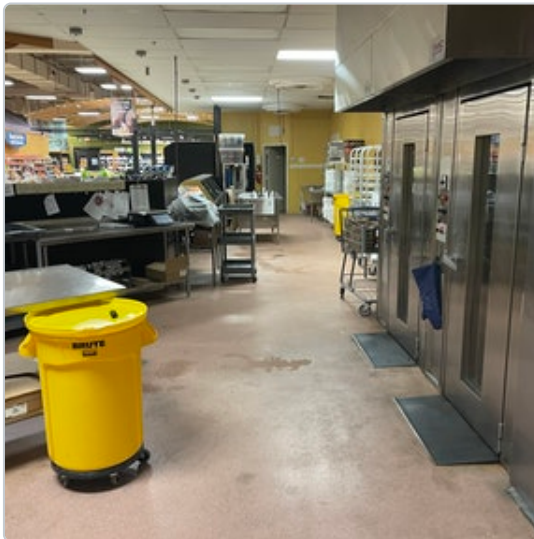
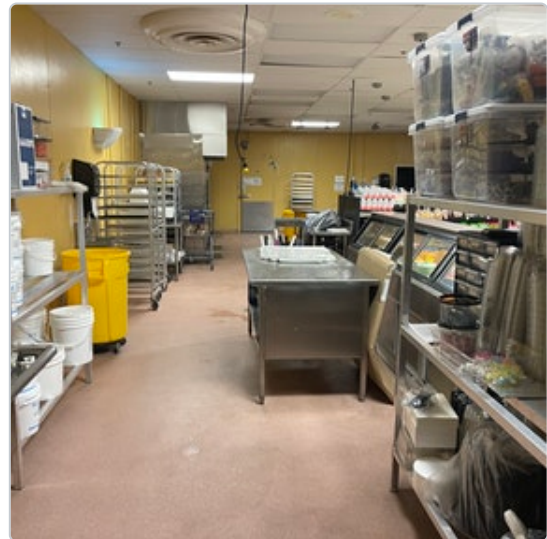
Post 13 - Deli grease drain - prep area verifications

The deli prep area floor drains, prep sinks, and mop sink were confirmed to go to CO7 line.

All grease prep area sinks and drains were confirmed to go to a grease retention structure.

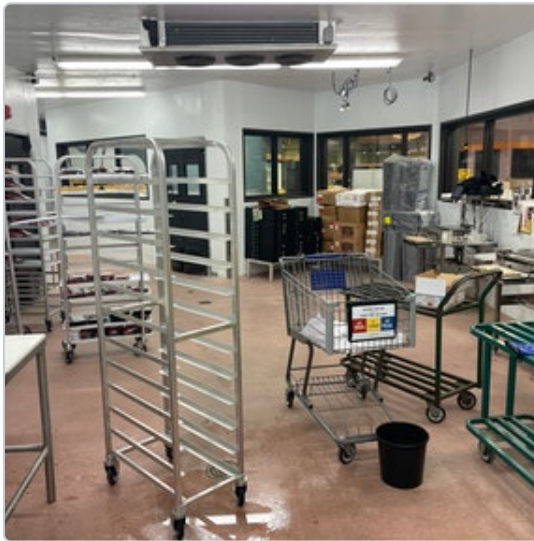
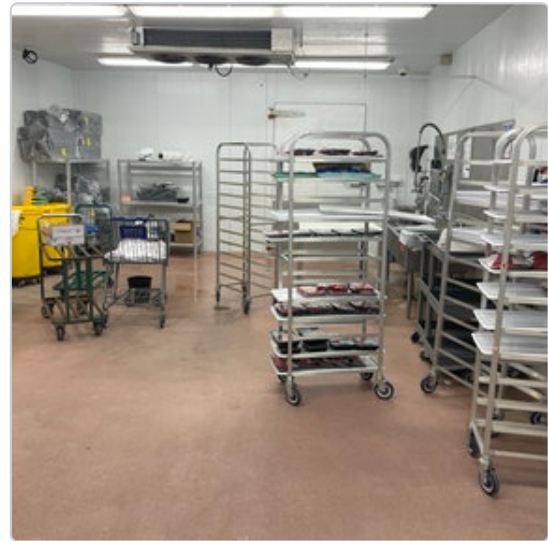
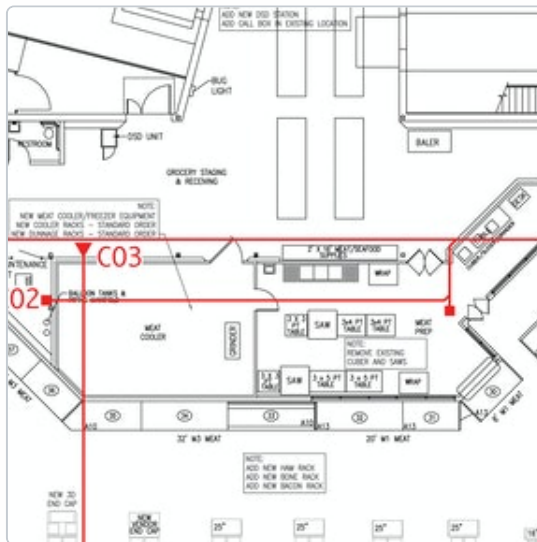
Post 12 - Meat grease drain - prep area verifications

The meat prep area floor drains and prep sinks were confirmed to go to CO1/CO2 lines.

The grocery storage mop sink was confirmed to go to CO3 line.

The grocery storage mop sink is not serviced by a grease retention structure.

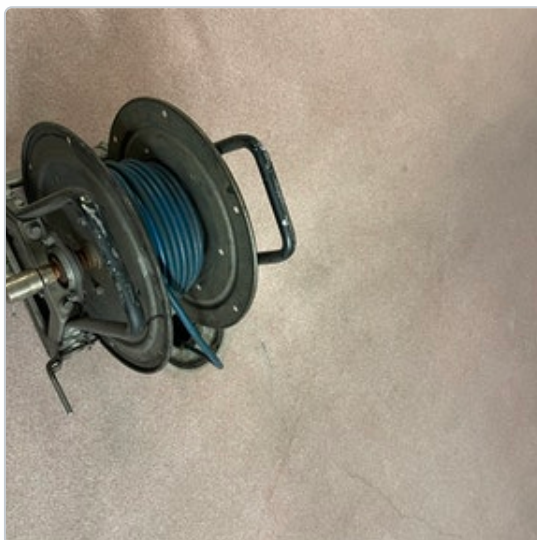
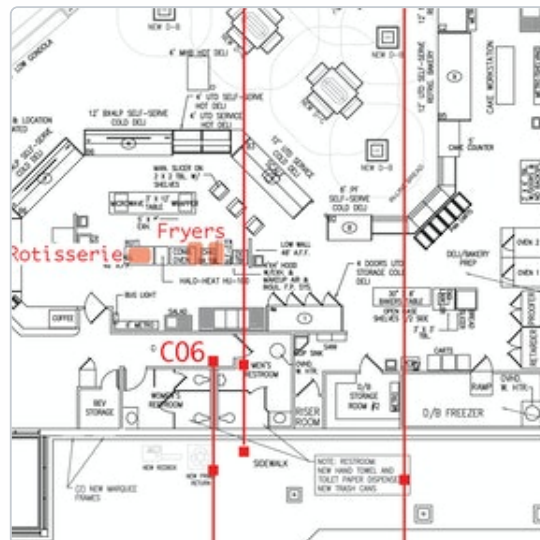
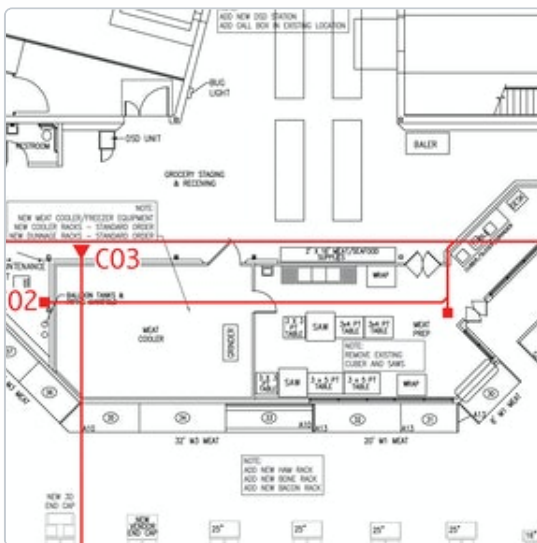
Post 10 - All individual prep area grease waste drains were cleaned with mini jet kit.

Deli drains were flow tested due to inaccessible cleanout.

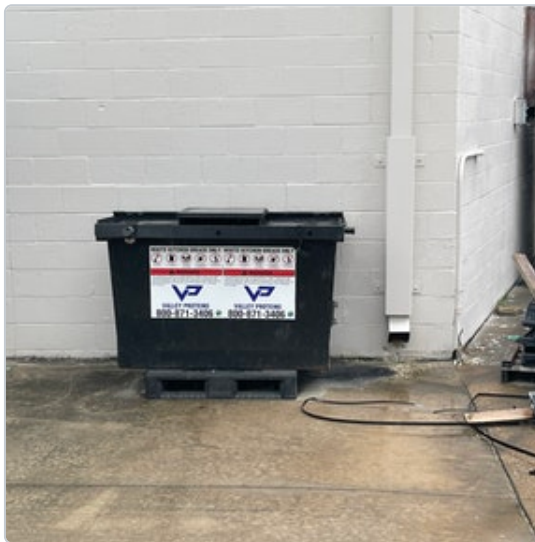
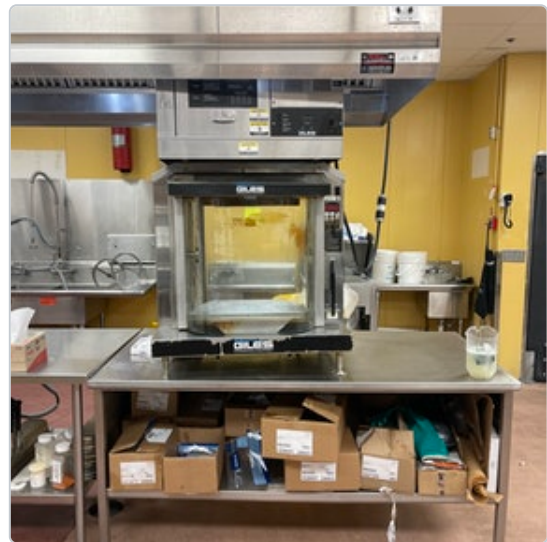
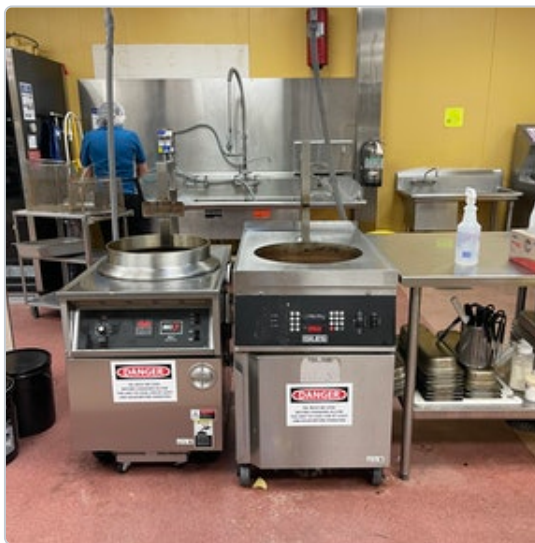
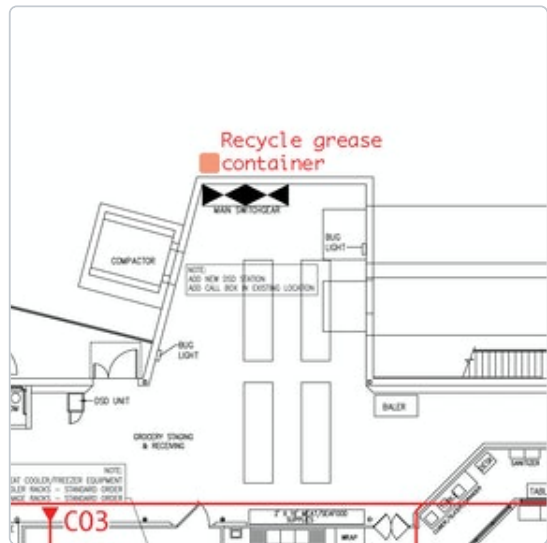
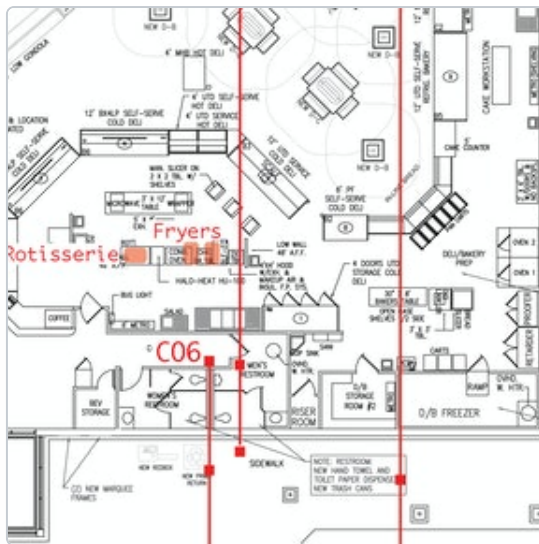
Post 11 - Deli Equipment

Recycle grease container verified to be onsite.

Rotisserie and fryers appear to be manually emptied.

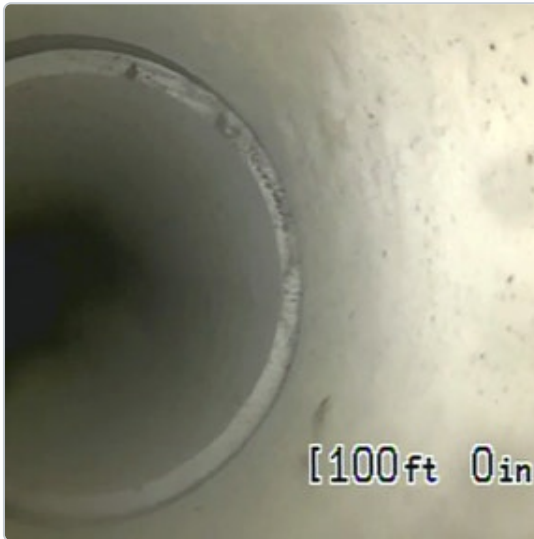
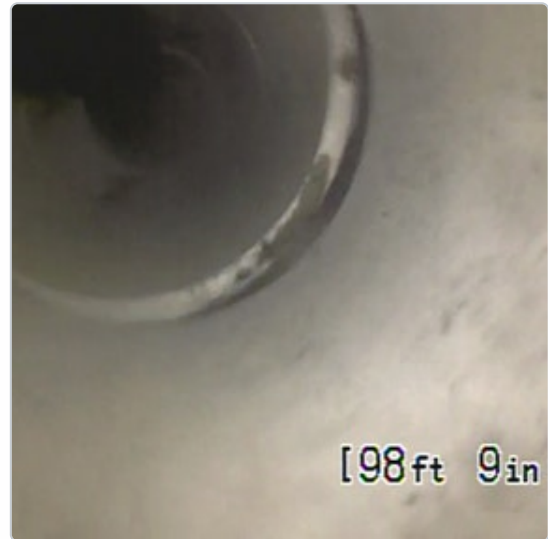
Post 25 - CO1 line (for reference)

Invert elevation is 19.5" BFF. Jetted line. Filmed backwards from CO7 line. Joint offset at 98' and 100'.

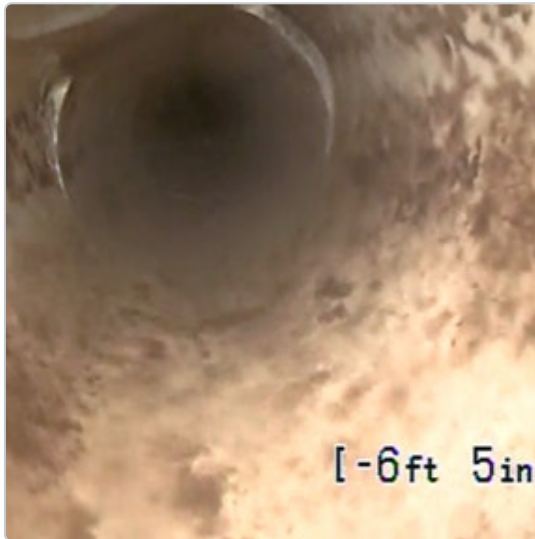
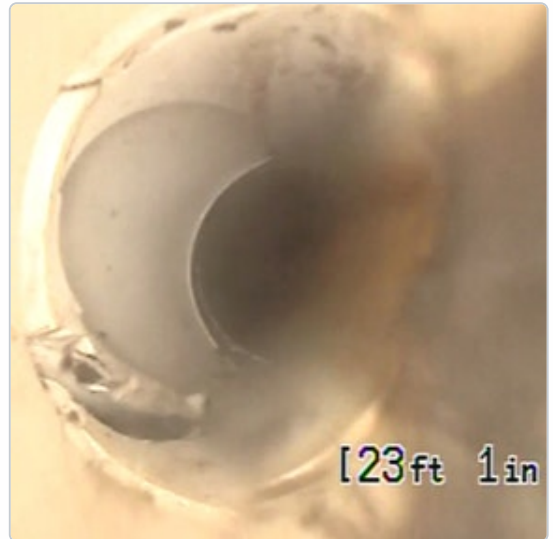
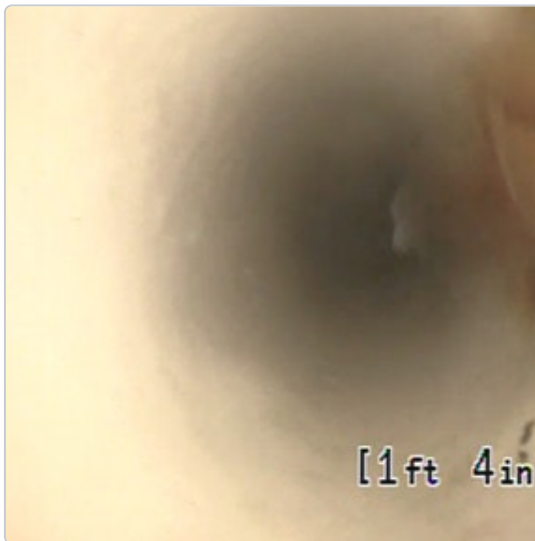
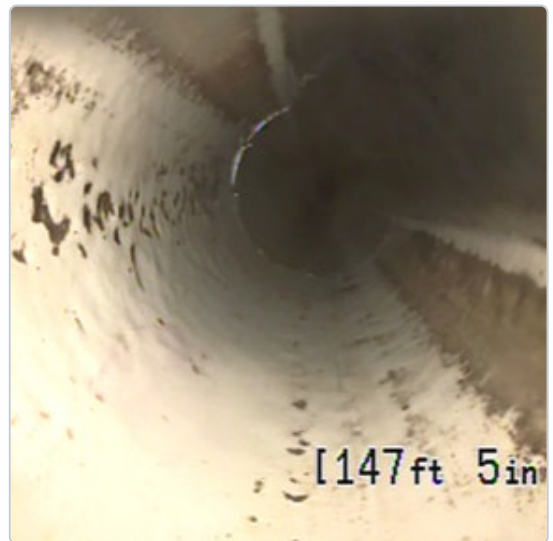
Post 23 - CO3 line (for reference)

Filmed backwards from site line. Joint offset at 1'. Pipe deformation at 6'. Fracture at 28'. Sag from 146' to 157' (1").

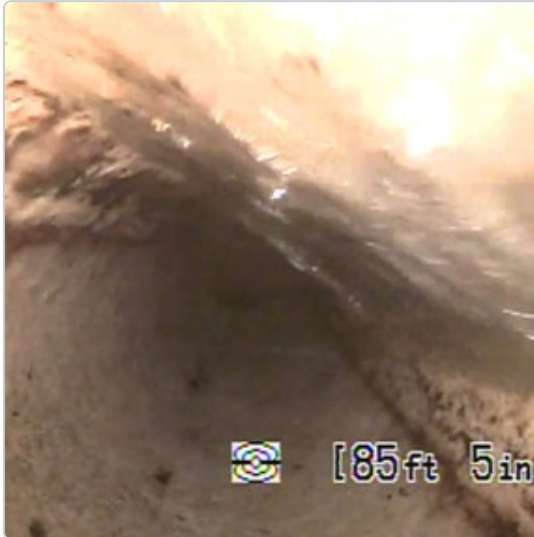
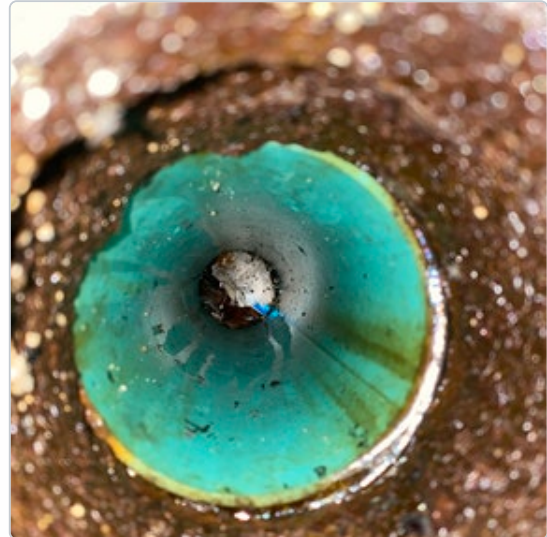
Post 21 - CO5 line (for reference)

Invert elevation is 20.25" BFF. Filmed backwards from issue at 157'. Sag, caused by blockage, from 85' to 157' (2"+; with camera under water part of issue). Blockage at 57'; 100% line loss.

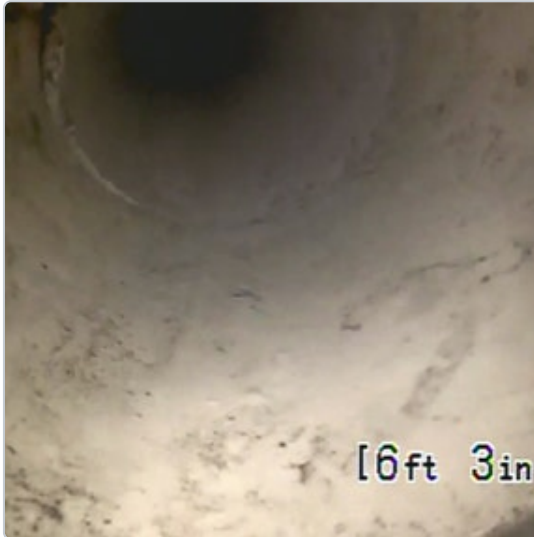
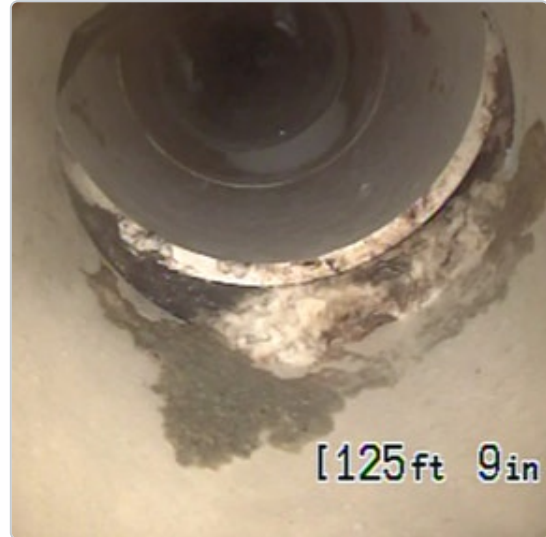
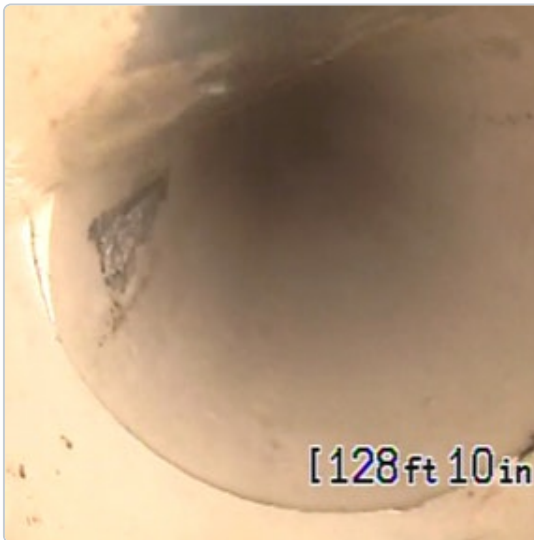
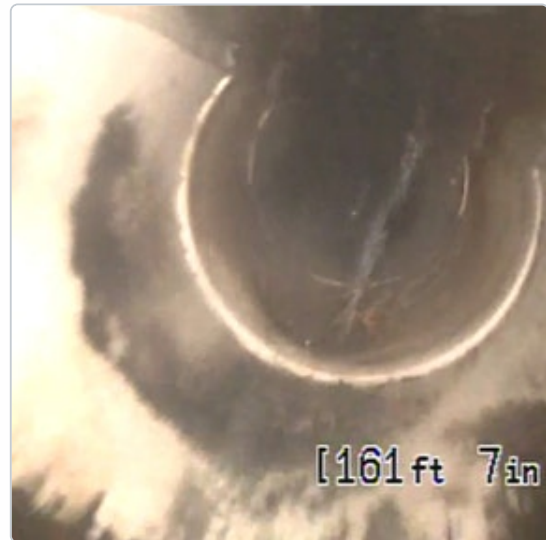
Post 19 - CO7 line (for reference)

Invert elevation is 15.5" BFF. Jetted line. Filmed backwards from grease interceptor. Joint offset at 7'. Joint offset at 126' and 128'. Sag from 147' to 175' (1"; with camera under water part of issue).
