*Commonwealth Environmental Associates, Inc.*

August 25, 2023

RE: Asbestos Survey Findings Report  
Store 2654  
610 E. King Street  
Kings Mountain, North Carolina  
CEA Project No. 16323

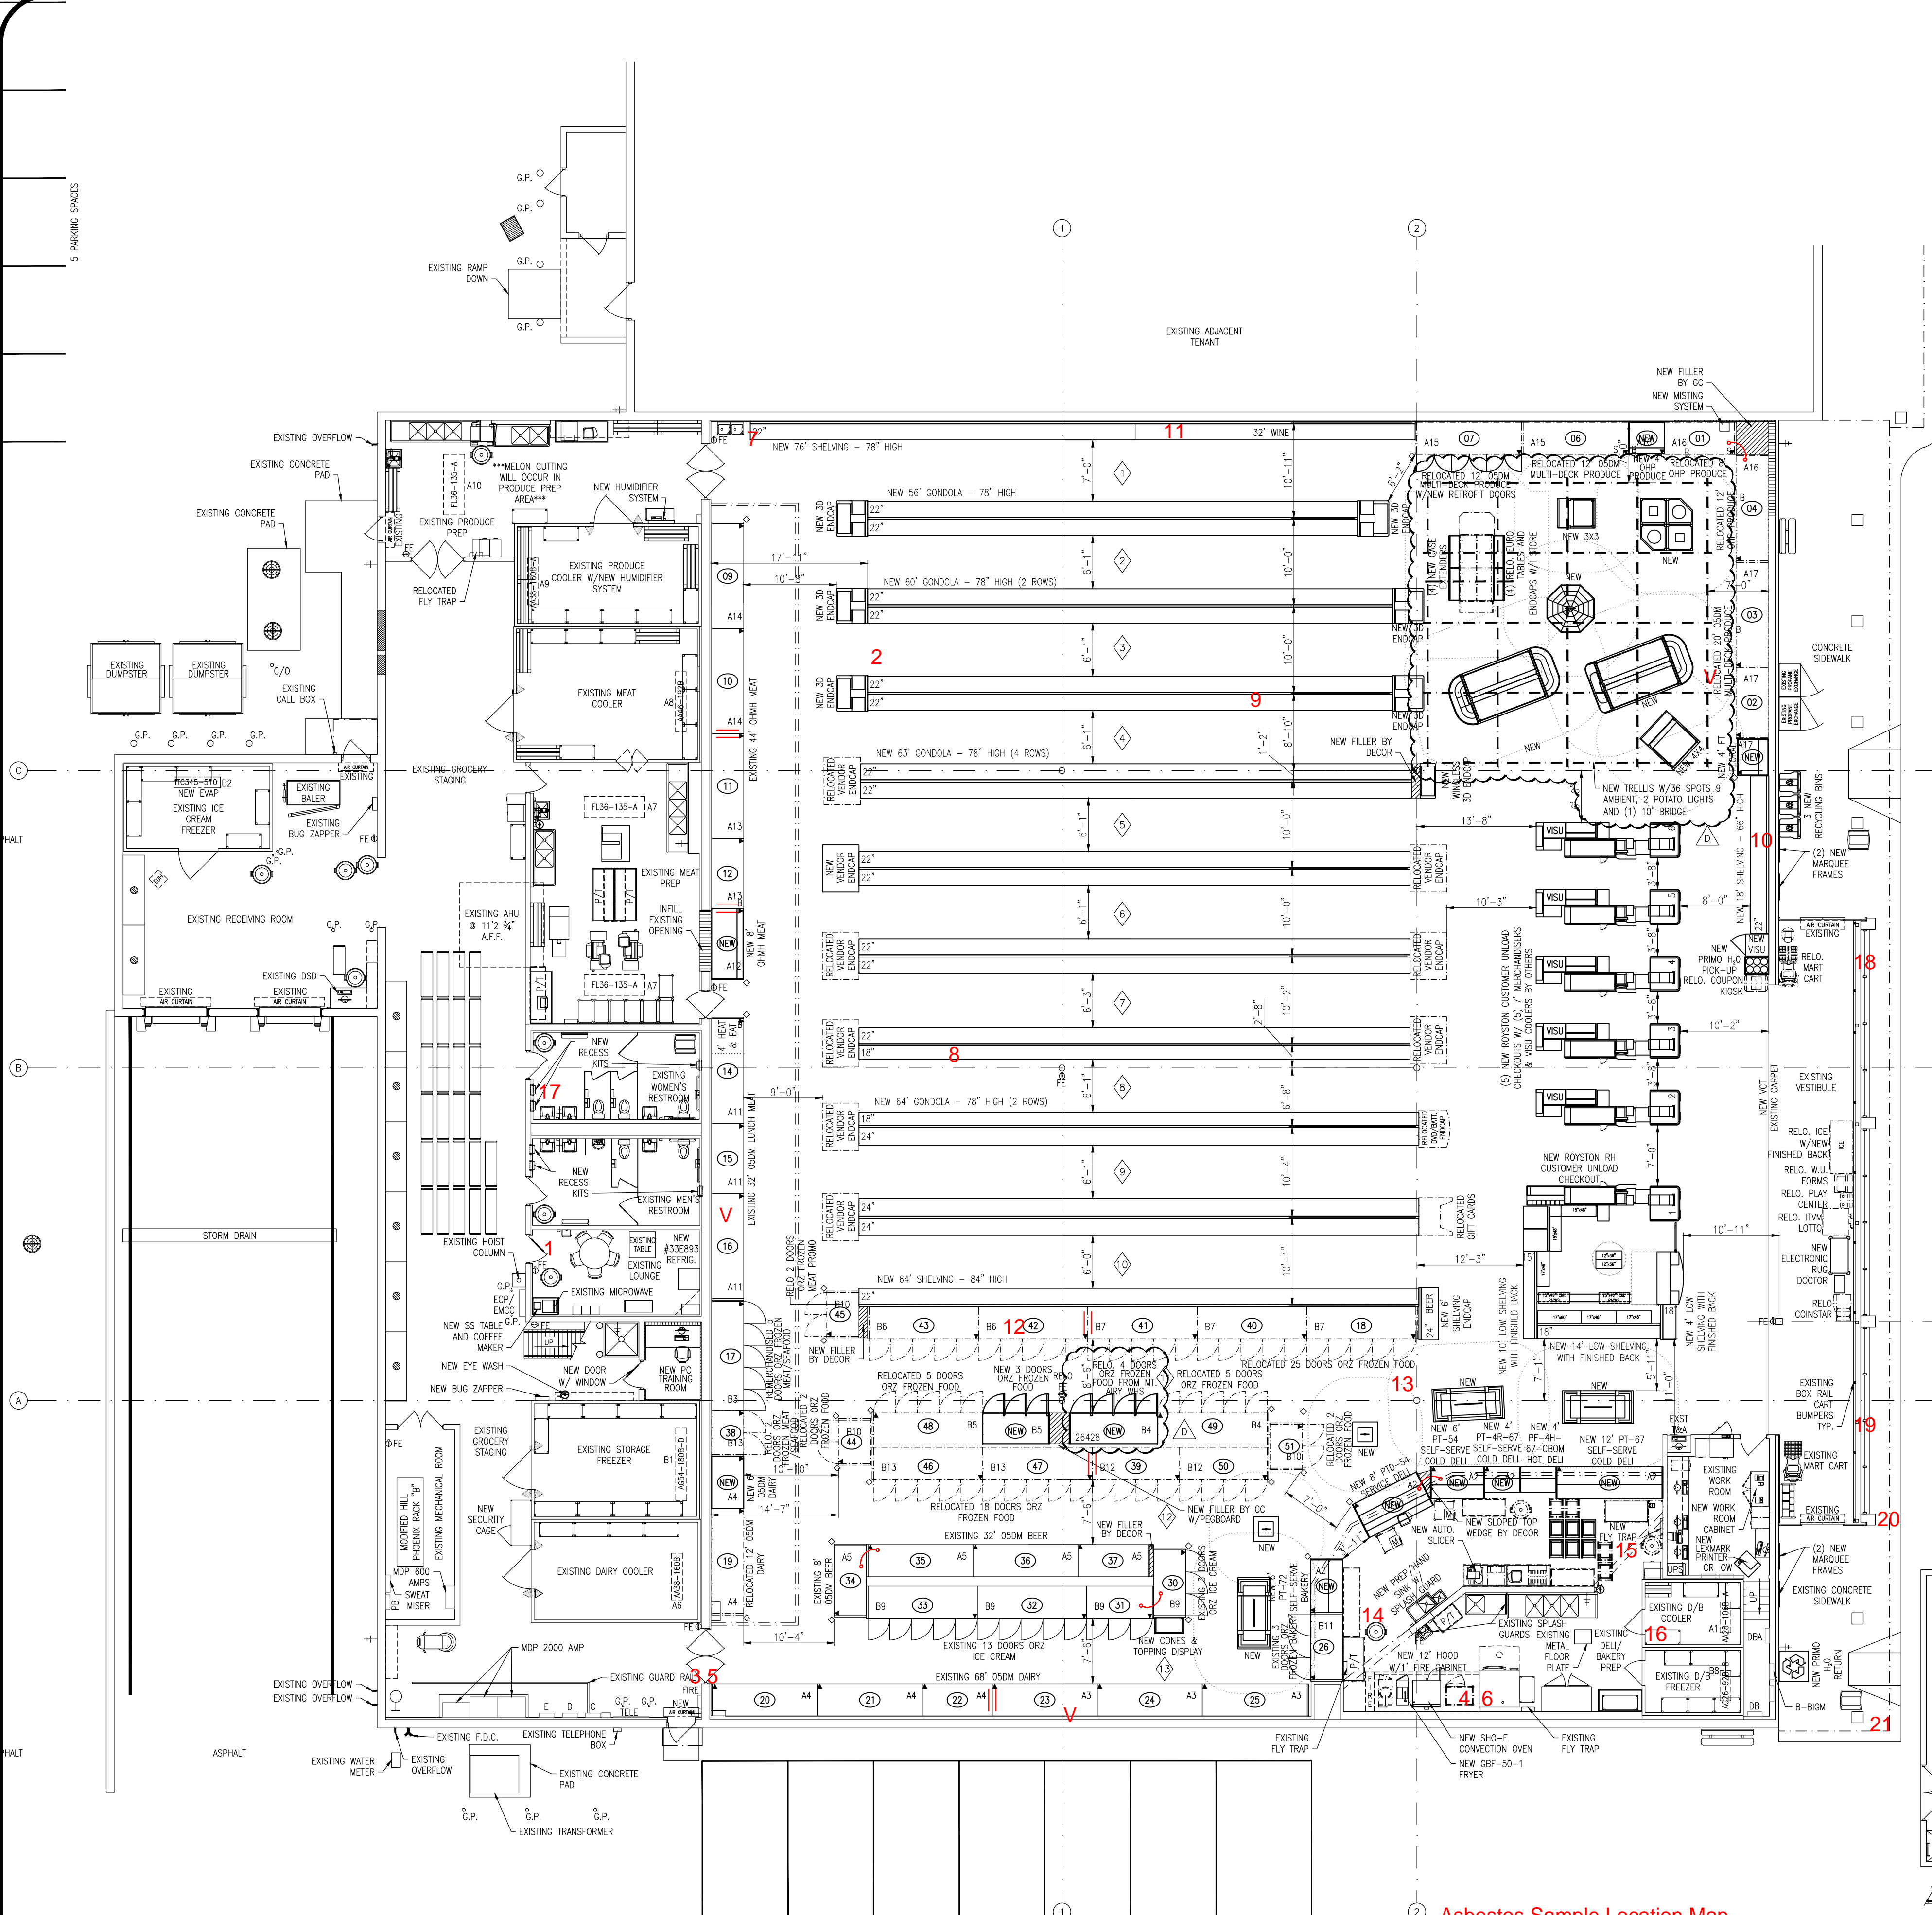
Asbestos Sample Location Map

CEA submitted the twenty-one (21) samples collected within the study area of Store 2654 to Eurofins CEI located in Cary, North Carolina for PLM analysis. Including the laboratory separated layers, twenty-seven (27) samples were analyzed during this study. Of the twenty-seven (27) samples analyzed, none were reported to contain asbestos. The EPA defines asbestos containing materials as any material containing 1% or greater asbestos fiber content. OSHA defines asbestos containing material as any material containing any detectable percentage of asbestos. Certificates of Analysis are presented as Attachment B. Sample locations are illustrated on the sample location map presented as Attachment C.

Notes: Numbers depict approximate sample location. "V" denotes visual inspection.
