FOOD LION #2654 PARTIAL DRAIN SURVEY, 12-04-2023 4/2/2015 - 1/18/2024

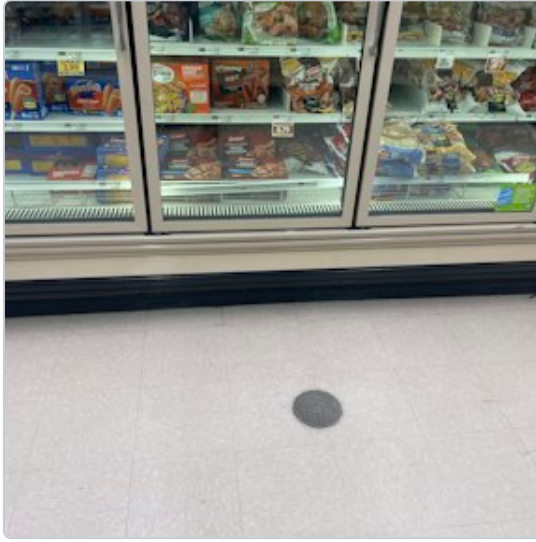
Post 45 - CO16 - Cleanout not present

Cleanout is to be located and made accessible, possibly covered by cases.

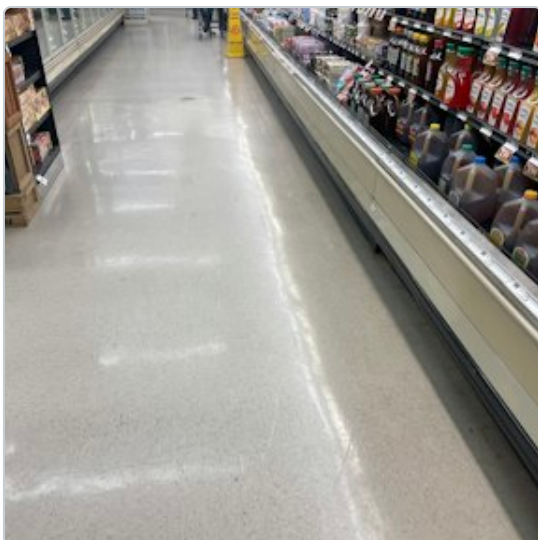
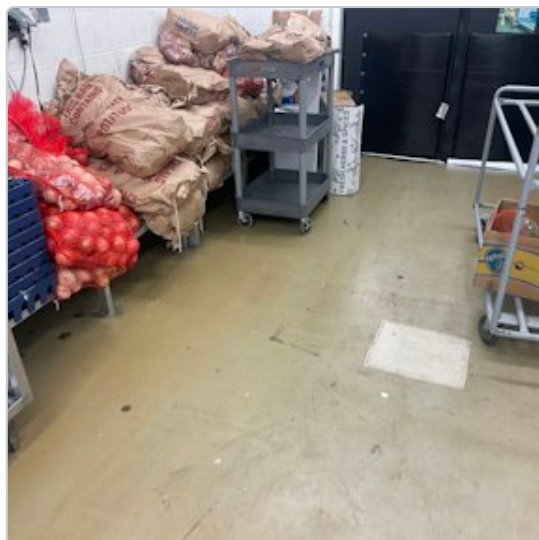
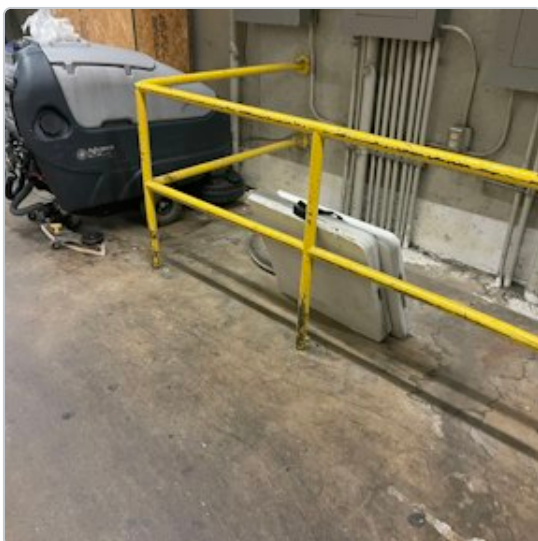
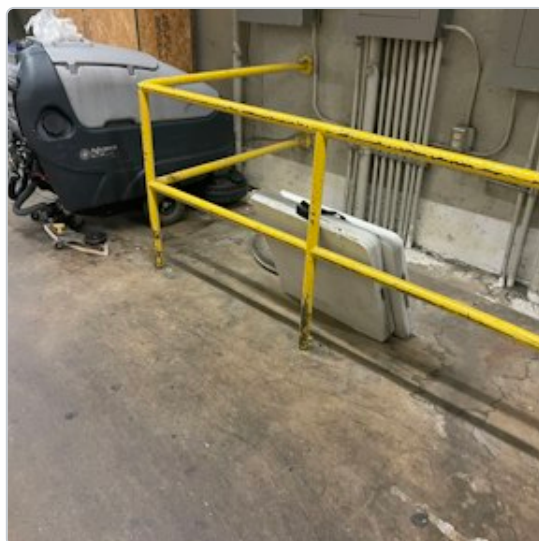
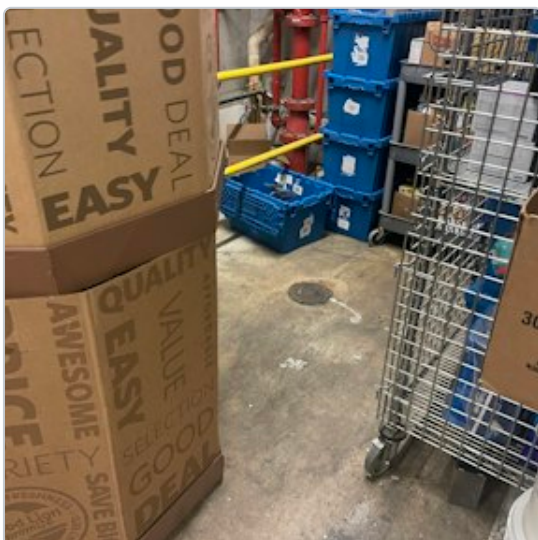
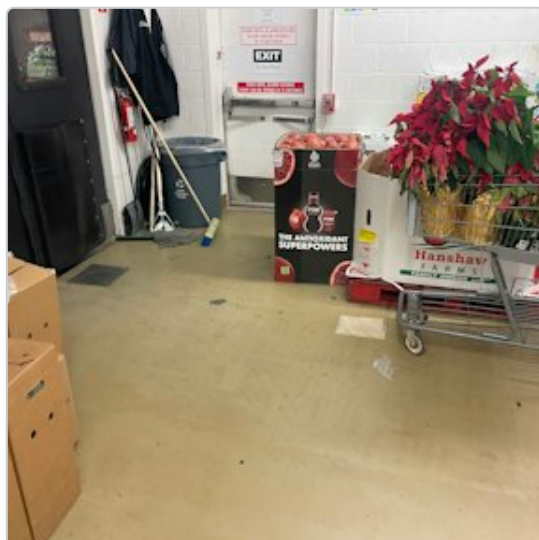
Post 40 - Construction supervisor to review cleanouts for possible repair

The sales floor cleanouts typically have surrounding tile damage / unlevel / should be cleared of excess wax and debris. Ensure all are level with finish floor upon closeout of remodel. Consider replacing fixtures.

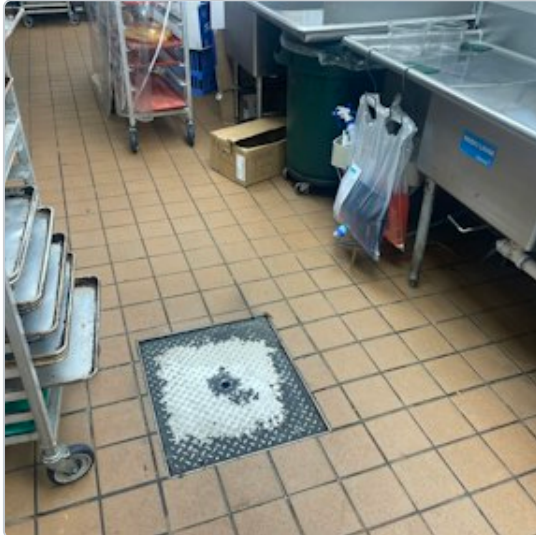
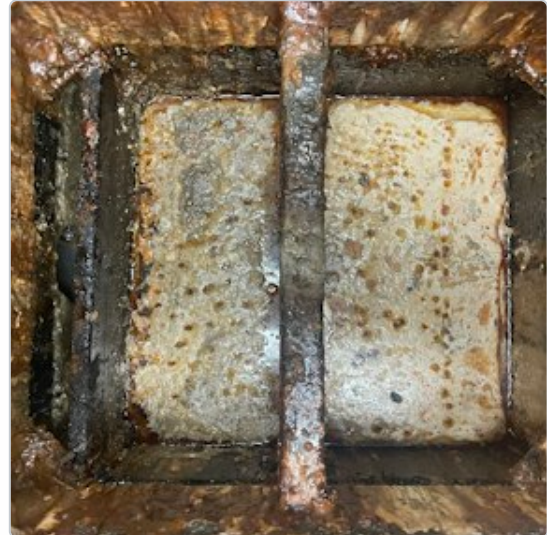
Post 43 - Grease Trap GT

Picks up deli prep three-compartment sink; outfall goes to CO3 line.

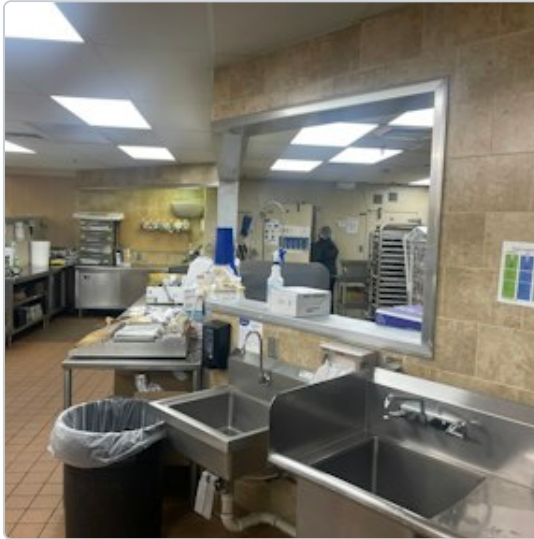
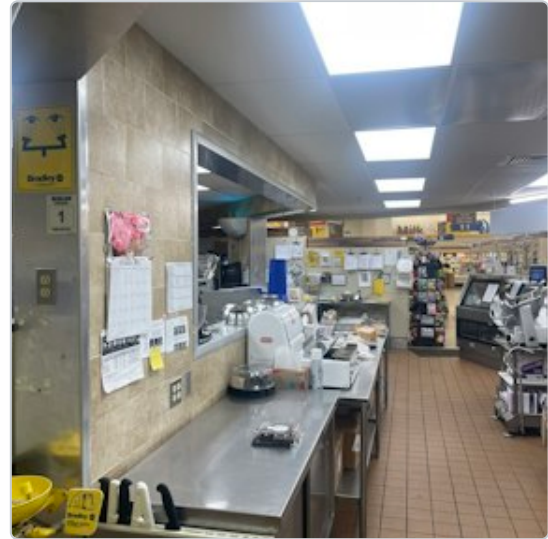
**Unassigned****Post 39 - Deli grease drains - prep area verifications**

The deli prep area drains were confirmed to go to CO1 and CO3 lines. Deli grease interceptor picks up the three-compartment sink in route to CO3 line.

Only deli prep area three-compartment sink is serviced by a grease retention structure. All other prep sinks and floor drains go directly to the sanitary sewer.

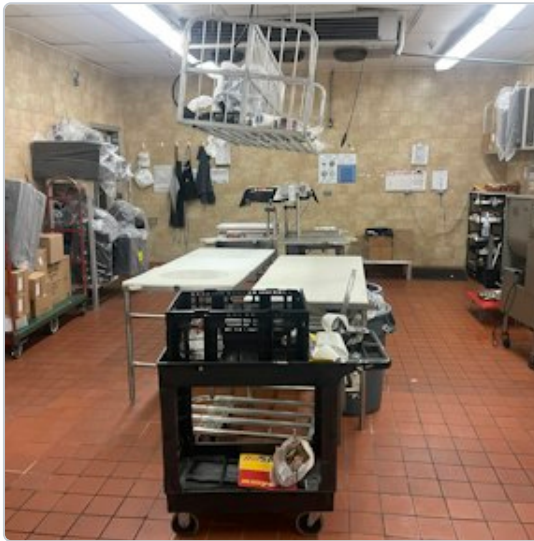
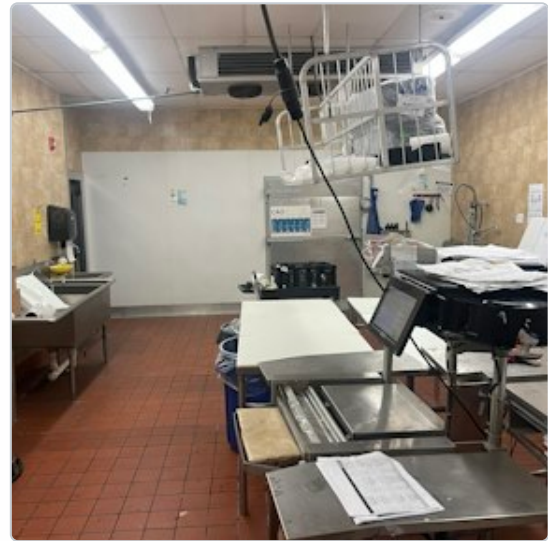
Unassigned**Post 44 - Meat grease drains - prep area verifications**

The meat prep area three compartment sink was confirmed to go to CO11 line. The meat prep floor drains and two compartment sink were confirmed to go to CO7 line. grocery storage mop sink goes to CO17 line.

Only the meat area three-compartment sink is serviced by a grease retention structure. All other prep sinks and floor drains go directly to the sanitary sewer.

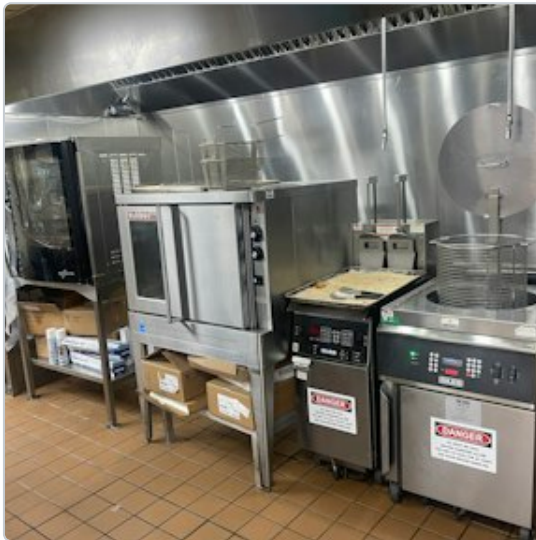
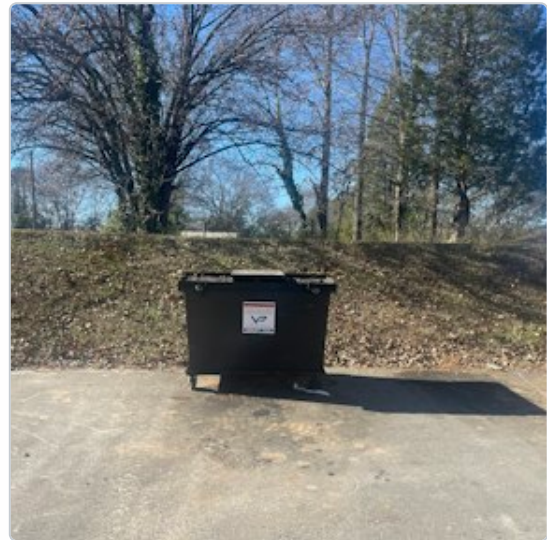
Post 38 - Deli Equipment

Recycle grease container verified on site.

Rotisserie, convection oven, and fryers appear to be manually emptied.

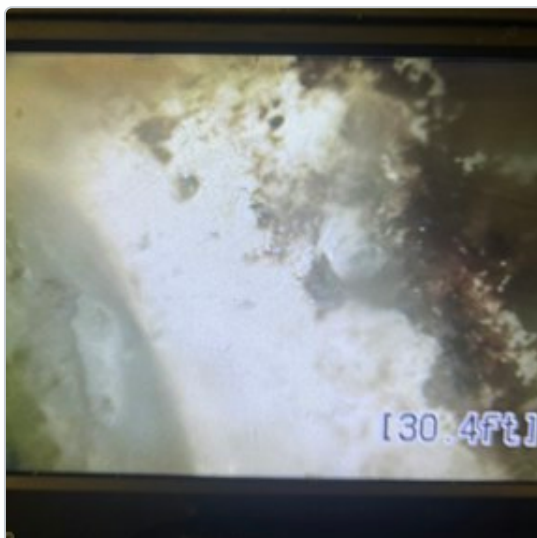
Post 46 - CO11 line (for reference)

Line in good shape.
