Visual Roof Inspection Report

Food Lion Store #:
2654

610 East King Street
King Mountain
NC
28086

05/23/2023

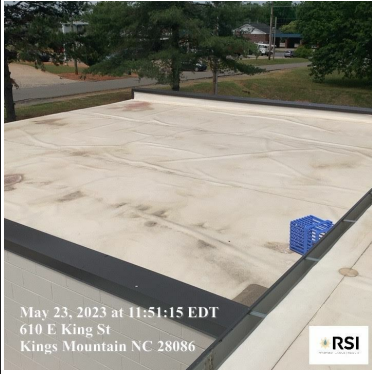
Deficiency Item #:	Deficiency Detail:	Correction:	Code:	Photo:	Quantity:	Unit:	Total:
9	Section C: Overview photo.

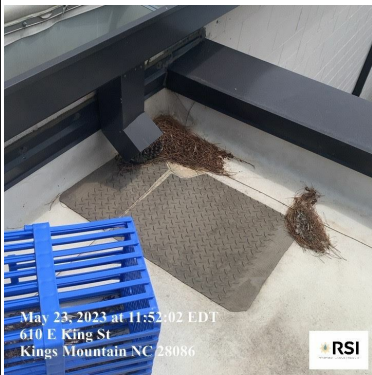
May 23, 2023 at 11:51:15 EDT 610 E. King St Kings Mountain NC 28086 RSI		Item	\$0.00
10	Debris on the roof surface.	Remove.	2
