FOOD LION #2839 REVISED DRAIN SURVEY PER ENGINEERING REVIEW

11-08-2021 5/17/2021 - 11/16/2021

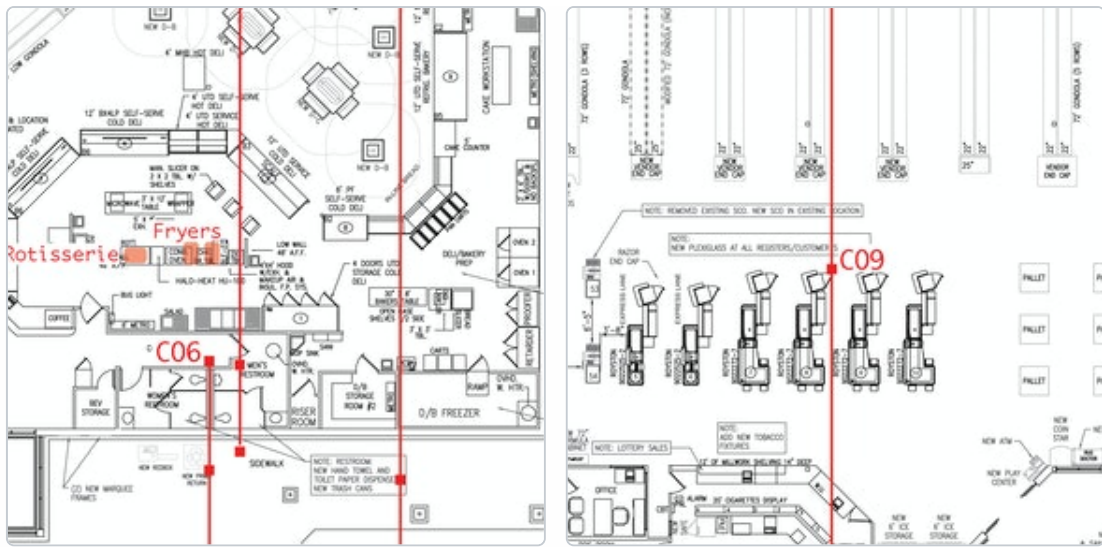
Post 3 - Construction Manager to review cleanouts for possible repair (for reference)

The sales floor cleanouts typically have surrounding tile damage / unlevel / should be cleared of excess wax and debris. Ensure all are level with finish floor upon closeout of remodel. Consider replacing fixtures.
